**Flood Control Project Maintenance  
Levee Inspections**  
**LMA District Cover Sheet**  
**Spring 2019 Levee Inspection Results**

**Reclamation District No. 0999 Netherlands**

**Spring 2019 Levee Inspection Results**

Waterway			Bank	Unit Miles
Unit No. 01 Yolo Bypass			Left	15.41
	Spring (March - May)	Summer (June - August)	(September - November) Fall	Winter (December - February)
Unit Maintenance Rating (Fall Only)				
Date of Inspection	3/21/2019 - 3/21/2019			
DWR Inspector	Luz Dial			
Accompanied By

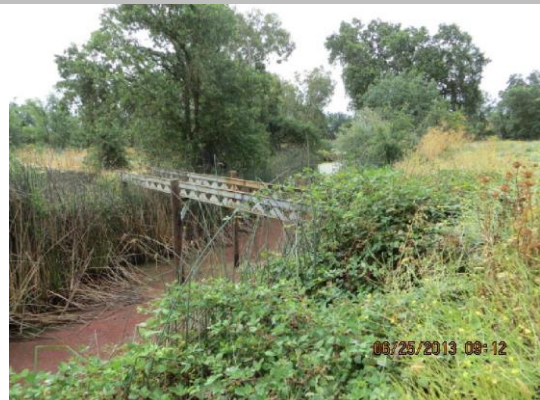
Photo 3 of 3 : UCIP\_SP\_2019\_53368\_25189.jpg

Pump platform visible off LS toe, but no appurtenances remain.

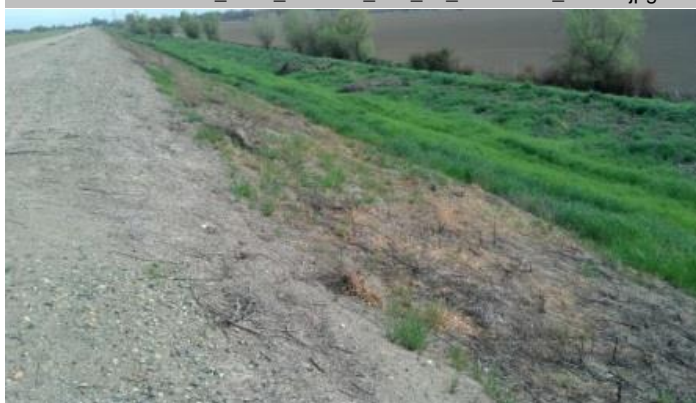
Photo 3 of 3 : SP\_2019\_RD0999\_232\_51\_20190307\_00033.jpg

LM Start	3.22	Rating **	M	Issue No.	51 (cont)	
LM End	3.22	Issue Type +	Ma	Location *	LS	
Category	Earthen Levee			GPS Latitude/Longitude		
				Start		End
Item	Slope Stability			38.459399 °		38.459399 °
				-121.587523 °		-121.587523 °
DWR ID	DWR_RD0999_01_s_2013_51					
Comment Code						
S1 : Repair slope instability.						
Inspector Comment						
Depression on landward shoulder and slope 40' x 20'. Earthen material appears to be sliding toward levee toe.

Looking north at depression on landside shoulder and slope. Spring 2016

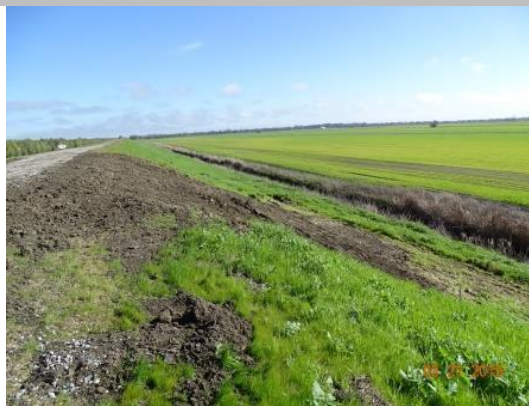
Photo 1 of 1 : SP\_2019\_RD0999\_232\_43\_20190325\_00066.jpg

LM Start	5.21	Rating **	M	Issue No.	43
LM End	5.21	Issue Type +	Ma	Location *	LS
Category	Earthen Levee			GPS Latitude/Longitude	
				Start	End
Item	Slope Stability			38.432322 °	38.432322 °
				-121.600123 °	-121.600123 °
DWR ID	DWR_RD0999_01_s_2019_43				
Comment Code					
S1 : Repair slope instability.					
Inspector Comment					
Complete repair of a ~60' length of slip.

View of slip on landside slope. Spring 2019

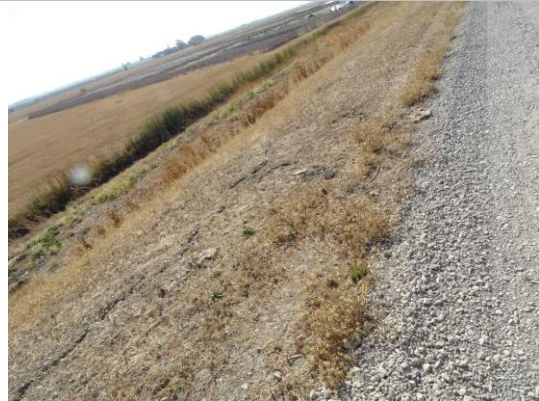
Photo 1 of 1 : SP\_2019\_RD0999\_232\_16\_20190307\_00005.jpg

LM Start	8.17	Rating **	A/W	Issue No.	16
LM End	8.17	Issue Type +	Ma	Location *	LS
Category	Earthen Levee			GPS Latitude/Longitude	
				Start	End
Item	Cracking			38.391963 °	38.391963 °
				-121.618782 °	-121.618782 °
DWR ID	DWR_RD0999_01_f _ 2018_16				
Comment Code					
CR1 : Monitor and have inspected by geotechnical engineer.					
Inspector Comment					
Monitor desiccation cracks on slope.

View of desiccation cracks on levee slope. Fall 2018

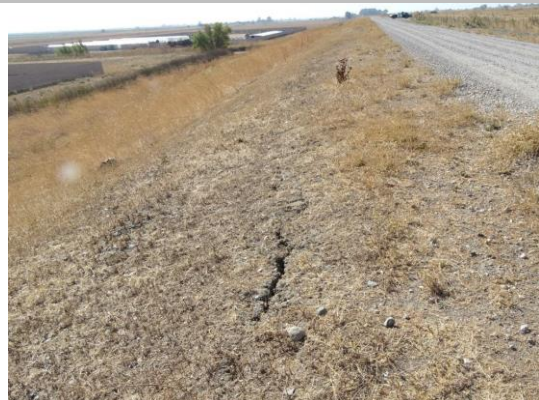
Photo 1 of 1 : SP\_2019\_RD0999\_232\_17\_20190307\_00006.jpg

LM Start	8.49	Rating **	A/W	Issue No.	17
LM End	8.49	Issue Type +	Ma	Location *	LS
Category	Earthen Levee			GPS Latitude/Longitude	
				Start	End
Item	Cracking			38.387645 °	38.387645 °
				-121.620810 °	-121.620810 °
DWR ID	DWR_RD0999_01_f_2018_17				
Comment Code					
CR1 : Monitor and have inspected by geotechnical engineer.					
Inspector Comment					
Monitor desiccation cracks on landside shoulder.

View of desiccation cracks on levee shoulder. Fall 2018

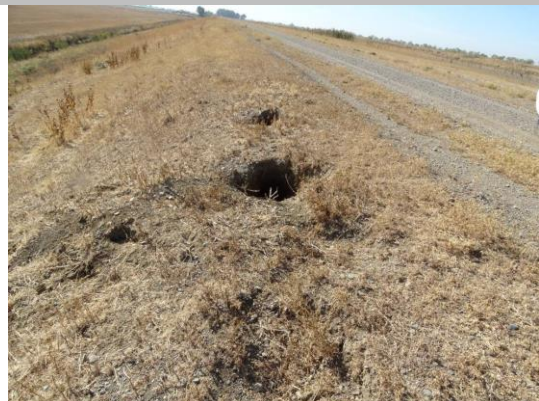
Photo 1 of 1 : SP\_2019\_RD0999\_232\_18\_20190307\_00007.jpg

LM Start	8.80	Rating **	U	Issue No.	18
LM End	8.80	Issue Type +	Ma	Location *	LS
Category	Earthen Levee			GPS Latitude/Longitude	
				Start	End
Item	Animal Control			38.383468 °	38.383468 °
				-121.622748 °	-121.622748 °
DWR ID	DWR_RD0999_01_f_2018_18				
Comment Code					
A3 : No rodents visible, but rodent burrows visible; need to backfill and compact or grout burrows.					
Inspector Comment					
Backfill large animal burrows at shoulder and slope.

View of large animal burrows at shoulder and slope. Fall 2018

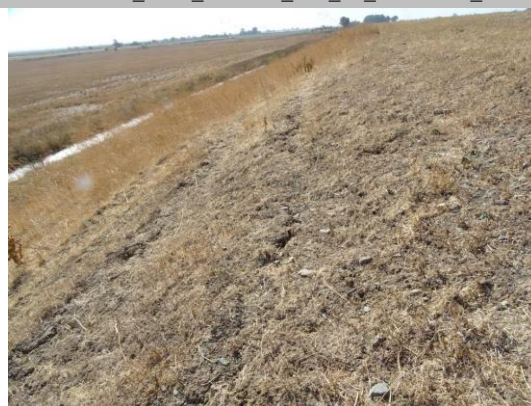
Photo 1 of 1 : SP\_2019\_RD0999\_232\_22\_20190307\_00008.jpg

LM Start	8.89	Rating **	A/W	Issue No.	22
LM End	8.89	Issue Type +	Ma	Location *	LS
Category	Earthen Levee			GPS Latitude/Longitude	
				Start	End
Item	Cracking			38.382145 °	38.382145 °
				-121.623363 °	-121.623363 °
DWR ID	DWR_RD0999_01_f_2018_22				
Comment Code					
CR1 : Monitor and have inspected by geotechnical engineer.					
Inspector Comment					
Desiccation cracks should be monitored.

View of cracking on slope. Fall 2018

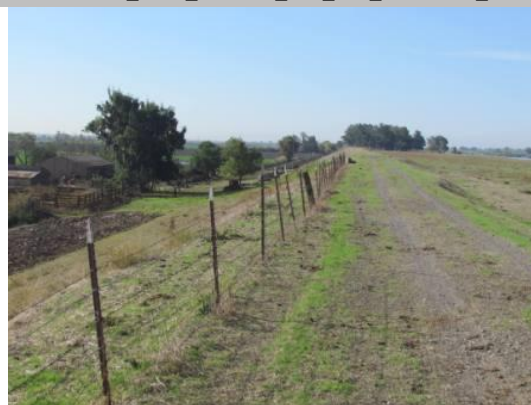
Photo 1 of 2 : SP\_2019\_RD0999\_232\_918\_20190307\_00039.jpg

Looking south at fence along landside shoulder.

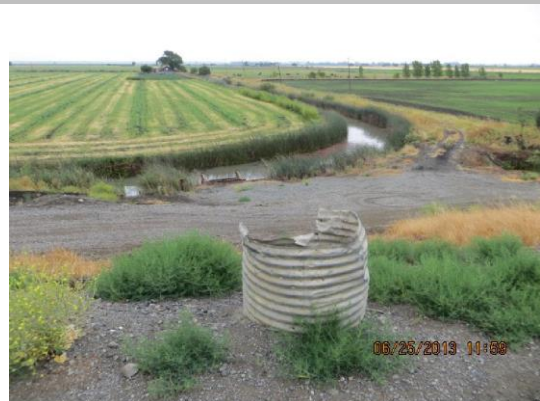
Photo 2 of 3 : UCIP\_SP\_2019\_53369\_25414.jpg

Siphon breaker in CMP riser on LS shoulder.

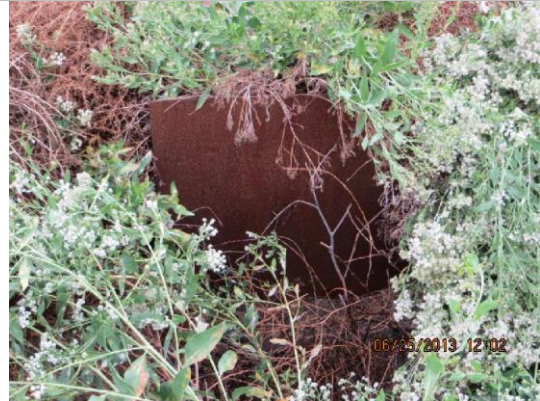
Photo 3 of 3 : UCIP\_SP\_2019\_53369\_25418.jpg

Steel plate welded over pipe on WS end at WS slope.

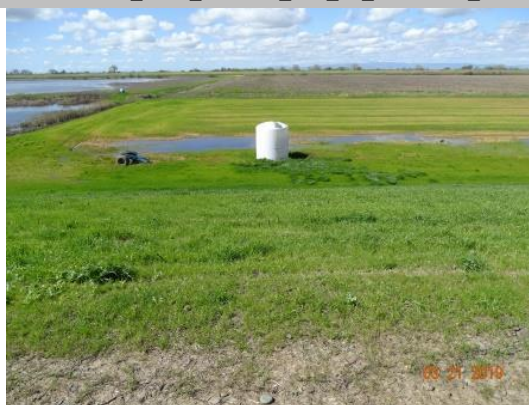
Photo 1 of 1 : SP\_2019\_RD0999\_232\_36\_20190325\_00069.jpg

View of tank placed on waterside berm. Spring 2019

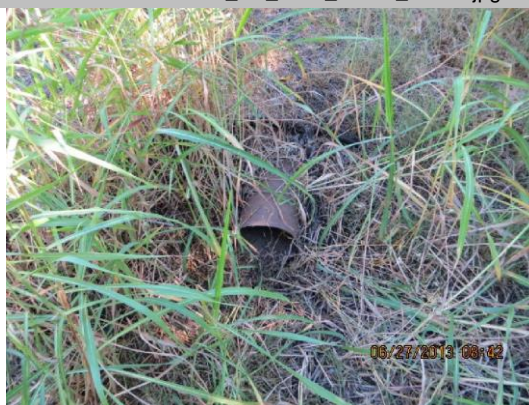
Photo 1 of 3 : UCIP\_SP\_2019\_15384\_25242.jpg

Pipe visible at concrete pad on WS slope.

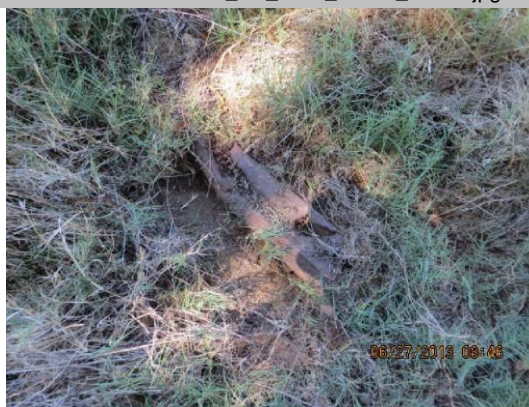
Photo 3 of 3 : UCIP\_SP\_2019\_15384\_25240.jpg

Damaged pipe on LS slope.

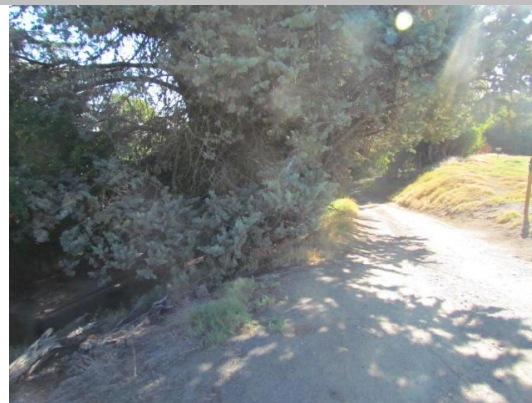
Photo 2 of 2 : SP\_2019\_RD0999\_233\_11\_20190307\_00010.jpg

Looking southwest at dense trees on landward slope.

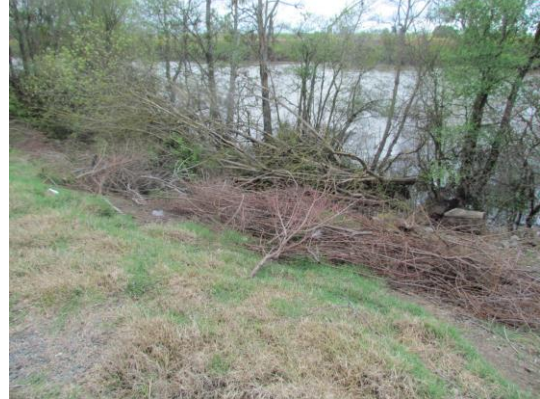
Photo 1 of 1 : SP\_2019\_RD0999\_234\_23\_20190307\_00015.jpg

Looking east at large pruning piles on waterward slope.

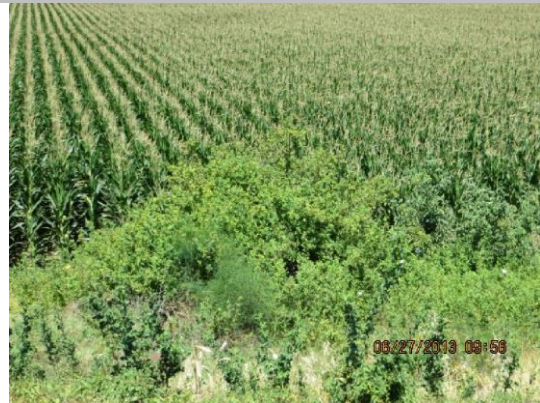
Photo 1 of 3 : UCIP\_SP\_2019\_15389\_25254.jpg

Pumphouse on LS slope covered in rose bush.

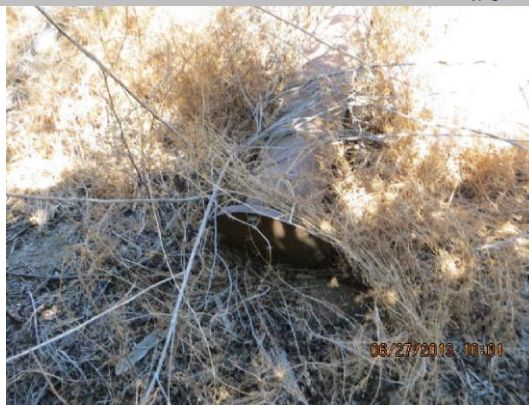
Photo 3 of 3 : UCIP\_SP\_2019\_15389\_25252.jpg

Steel plate on WS end of pipe.

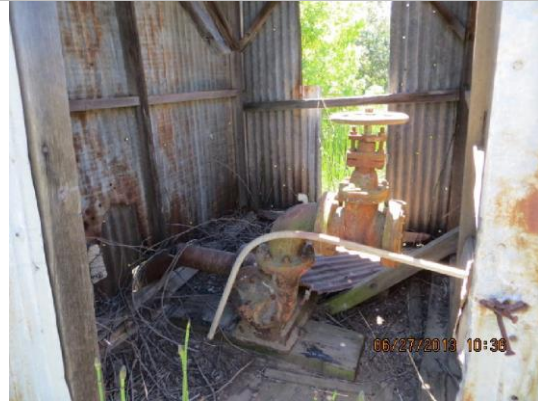
Photo 3 of 3 : UCIP\_SP\_2019\_15392\_25259.jpg

gatevalve inside pumphouse with no connection.

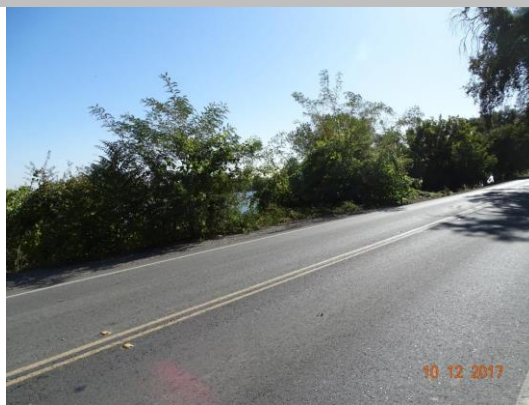
Photo 1 of 1 : SP\_2019\_RD0999\_235\_53\_20190307\_00026.jpg

Looking southeast at the waterside slope.

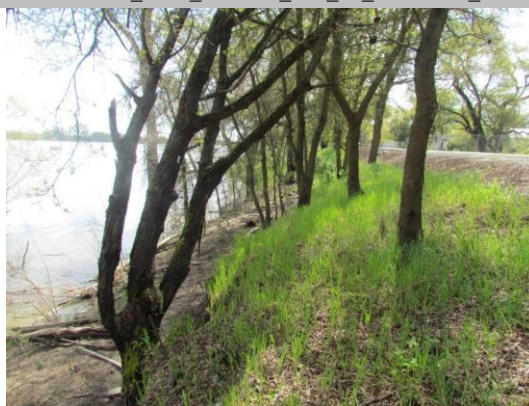
Photo 1 of 2 : SP\_2019\_RD0999\_235\_15\_20190307\_00007.jpg

Looking downstream at 2ft plus vertical erosion on waterward slope.

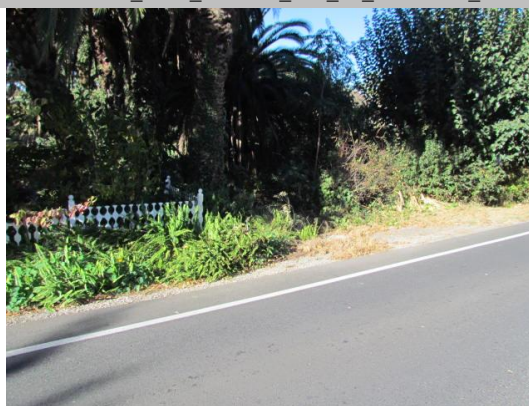
Photo 1 of 2 : SP\_2019\_RD0999\_235\_38\_20190307\_00014.jpg

Looking northwest at dense landscaping on landward slope and toe.

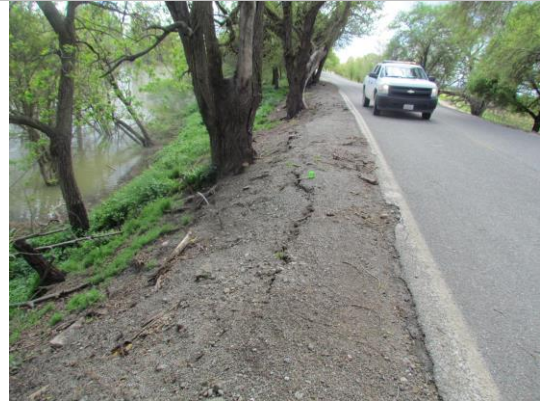
Photo 3 of 3 : SP\_2019\_RD0999\_236\_165\_20190307\_00072.jpg

Looking downstream at crack along waterward shoulder.

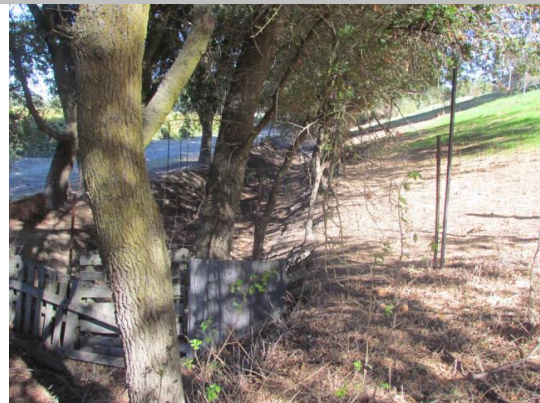
Photo 1 of 3 : SP\_2019\_RD0999\_236\_153\_20190307\_00062.jpg

Looking north at old irrigation ditch at landward toe.

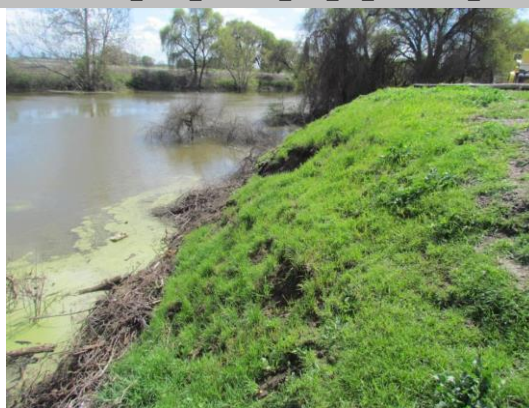
Photo 1 of 1 : SP\_2019\_RD0999\_236\_12\_20190307\_00008.jpg

Looking downstream at finger erosion on downstream side of slough.

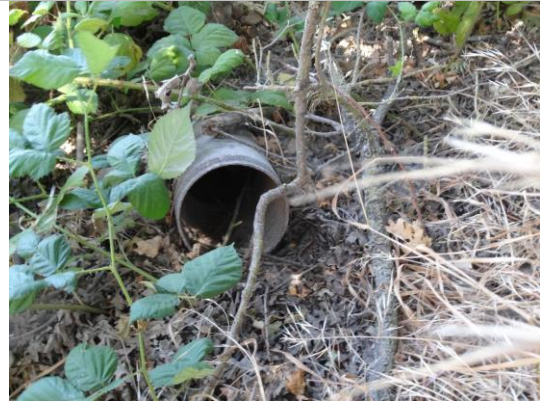
Photo 3 of 3 : UCIP\_SP\_2019\_53371\_75319.jpg

pipe on WS slope of levee below pipe penetrating levee. May have previously been connected.

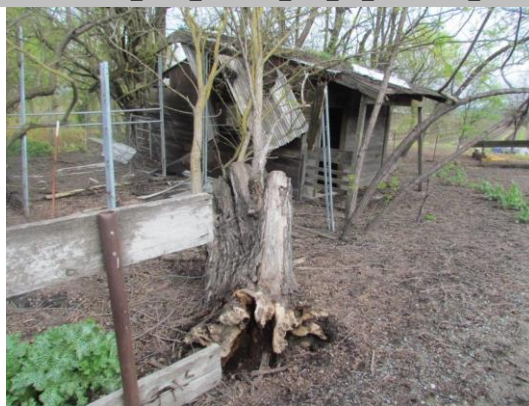
Photo 1 of 2 : SP\_2019\_RD0999\_236\_37\_20190307\_00019.jpg

Looking northwest at dilapidated horse pen and fallen tree on landward slope.
